GMC

Contents

Customer Care and Aftersales

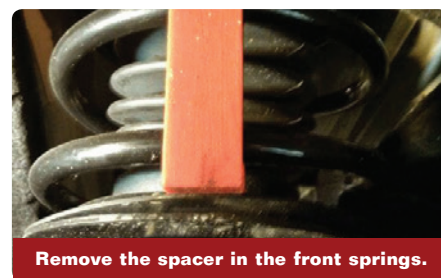
The factory-installed shipping spacers in the front coil springs provide additional clearance during vehicle transportation and MUST be removed when performing the PDI. With the vehicle on a hoist, remove the shipping spacer and repeat for the other side.

Remove the spacer in the front springs.

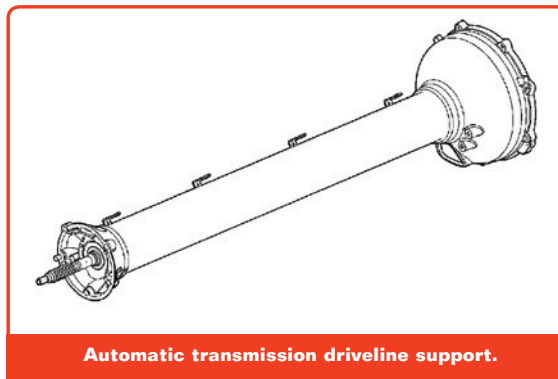
Corvette Driveline Support Alignment

TIP: The propeller input shaft front bearing positioning system is designed to withstand an insertion force of no more than 582 Y (130 lb). If the fastening bolts are used as an installation method, it may create force above this amount and damage the crankshaft thrust bearing.

When reinstalling the driveline support, the angle may be slightly off horizontally or vertically. This can make the driveline support

difficult to align. Do not use the bell housing attachment bolts to draw the driveline support tight against the bell housing. Any small amount of misalignment may cause the input splines of the propeller shaft to catch on the crankshaft, driving it forward. If the engine is started in this condition, it may cause the crankshaft thrust bearing to be immediately worn, necessitating engine replacement.

Refer to the appropriate Service Information for complete procedures on alignment and installation of the driveline support to ensure that the propeller shaft is properly aligned to the front hub bearing.

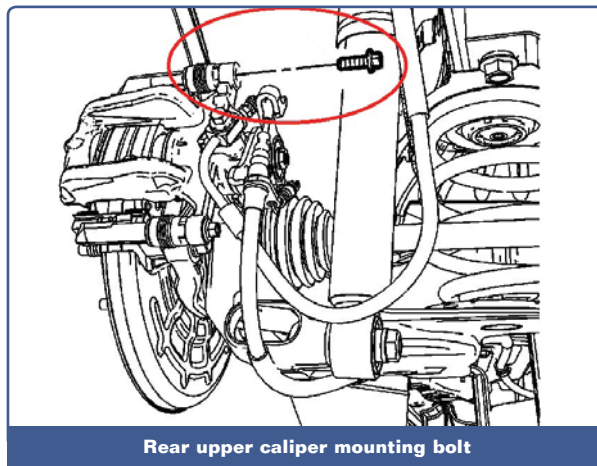
Rear upper caliper mounting bolt

On some 2013 Encore AWD and Trax AWD (Canada only) models, after the vehicle is first started, a rear brake noise may occur during the first time the brakes are applied when backing up. The noise also may occur the first time the brakes are applied with the vehicle in Drive. The vehicle may have been sitting only a few hours or overnight.

To eliminate the noise, install a dampener (P/N 13343688) and bolt (P/N 13343686) in place of the rear upper caliper mounting bolts. Refer to the appropriate Service Information (the Brakes section under Rear Disc Brake Pads Replacement) for bolt removal instructions and the proper torque specification.

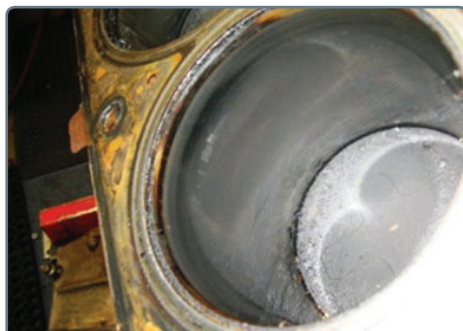
- **Cylinder damage or scoring** – the cylinder walls will contain grooves deep enough to catch with a fingernail.
- **An out-of-round cylinder bore** – the cylinder will contain areas where the crosshatch is missing or worn from different sections of the cylinder bore. If the crosshatch is all the way around the bore from top to bottom, the cylinder bore is not out-of-round.
- **Dirt intrusion** – If the filtering system has been compromised, the engine will wear out very quickly. Grit may be found in the intake runners and the cylinder bores may appear to be lightly sand blasted. The crosshatch will be faint without sharpness.

Out-of-round cylinder

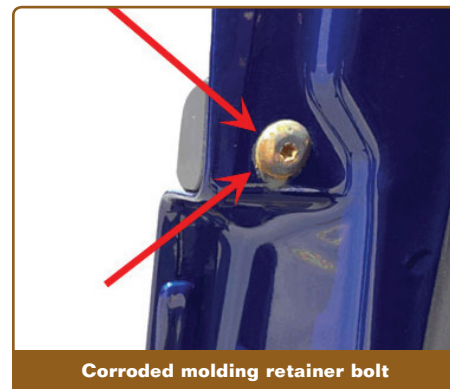
Some 2014 Silverado 1500 and Sierra 1500 trucks built prior to August 13, 2013 may have a front side door window belt molding retainer bolt that is corroded.

Corroded molding retainer bolt

Replace the bolt with part number 11515397. Apply Red Thread Adhesive (P/N 89021297, U.S.; P/N 10953488, Canada) or equivalent to the bolt threads.

Tighten the bolt to 27 lb.-in. (3 N-m).

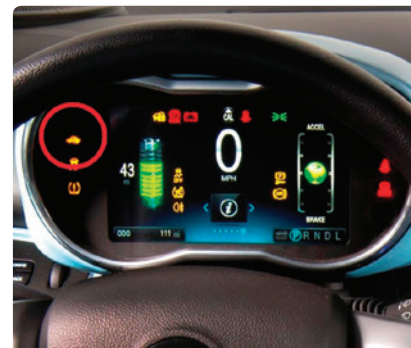
On some 2014 Spark EV models (RPO EN0), the air conditioning may be inoperative and/or the Service Vehicle Soon (SVS) MIL (resembles a car with an exclamation mark in the middle) may be illuminated. A history DTC P0071 (Ambient Air Temperature Sensor Performance) may be set.

Service Vehicle Soon MIL

Use GDS2 to capture any DTC Freeze Frame or Failure Records prior to clearing the DTCs. If DTC P0071 is current (failed during the current key cycle), follow the appropriate Service Information diagnostics.

If the vehicle build date is before July 15, 2013 and the DTC is set in history, or there is an intermittent no air conditioning concern, the Hybrid Powertrain Control Module 2 (HPCM2) software needs to be updated. Program the K114B (HPCM2) software using TIS2Web.

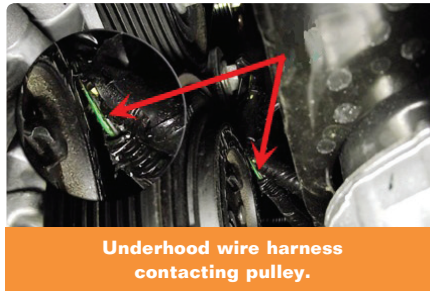
Buzzing Noise at Right Front Wheel

Some 2012-2013 LaCrosse, Regal; 2013 Malibu Eco; and 2014 Impala Eco models with eAssist (RPO HP6) may have a buzzing or humming noise heard in the right front at times, both when turning or driving straight. The Service Brake Assist message may be displayed or the ABS MIL or Service Engine Soon MIL may be illuminated. DTCs C027B (Brake Booster Electric Vacuum Pump), C0040 (Right Front Wheel Speed Sensor Circuit) and P0CBE (Drive Motor Coolant Temperature Sensor Circuit Low Voltage) may be set.

This condition may be caused by the underhood wiring harness contacting the crank pulley, air conditioning compressor pulley or accessory drive belt due to misrouting or not being secured properly.

Repair the wiring as needed or replace the harness. Properly route and secure the harness. Once wiring repairs are complete, confirm proper brake booster vacuum pump operation. The pump can be commanded on using GDS2. Clear all DTCs.
